CORTADO SERVICE BULLETIN #15.11.1

Applies to: Only Cortado serial numbers ZD1201 through ZD1251

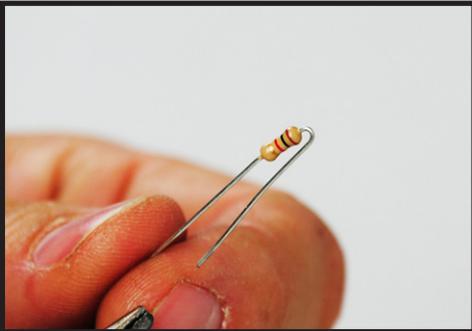
1. Bend one lead on the 1K resistor the same way you bent R8

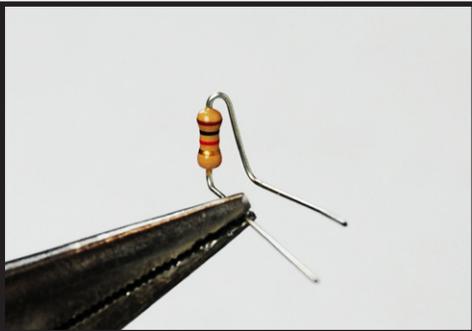
2. Bend both leads at a 90 degree angle, as pictured.

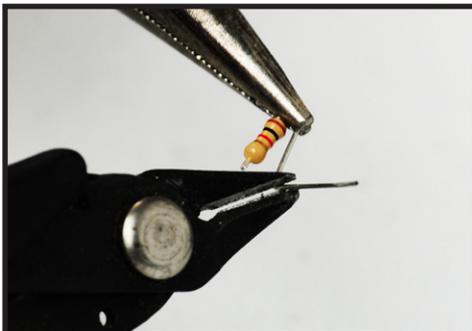
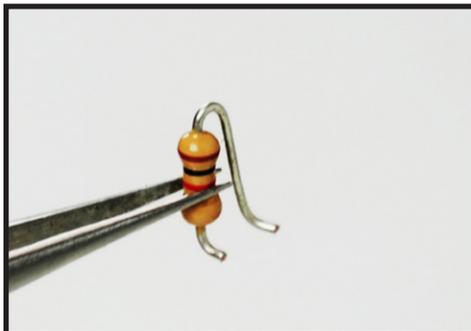
3. Cut the bent leads about 2mm after the bend.

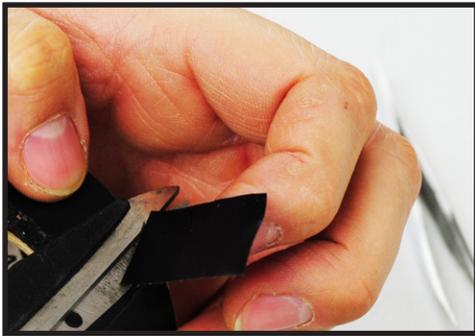
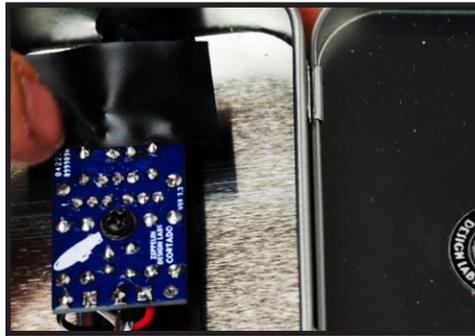
- Place a piece of electrical tape on the board to keep the resistor from shorting out against any other components.

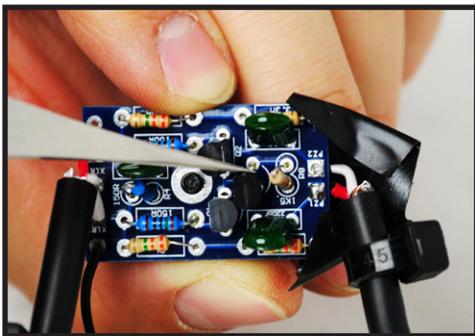
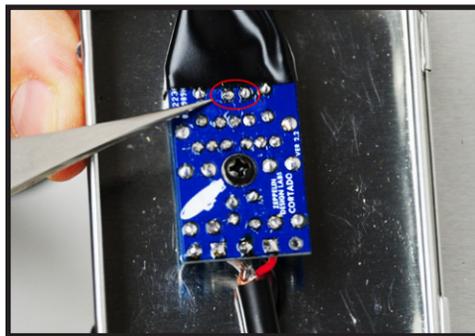
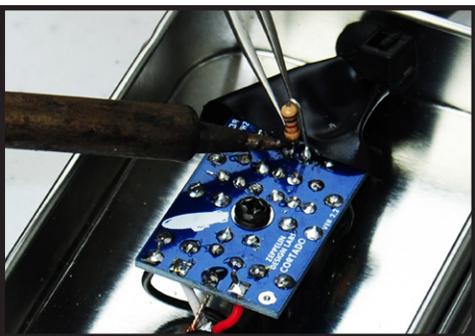
- Solder the 1K resistor on the pads of R8. Before you solder the resistor double check to make sure you know which pads are connected to R8. See photo.

The procedure consists of soldering the 1K resistor to the solder side of the board across the solder pads of R8.

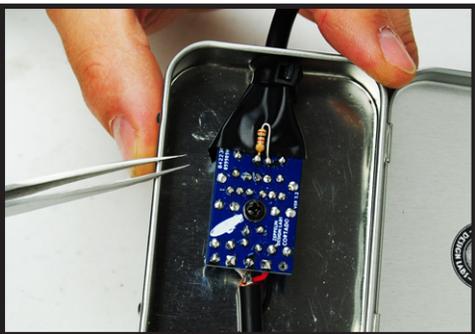
- Bend the resistor over against the electrical tape.

Once you have finished the soldering procedure double check the solder joints to make sure they are solid. The next step is to plug your Cortado into your mixer and see if this fixed the problem. If the issue was a low bias current, this should have fixed the problem.
